VICTORIAN NOTICE TO MARINERS No. 056(T)/21

Port of Portland Shoaling to the West of the Main Breakwater

Date: Tuesday 29th October 2019

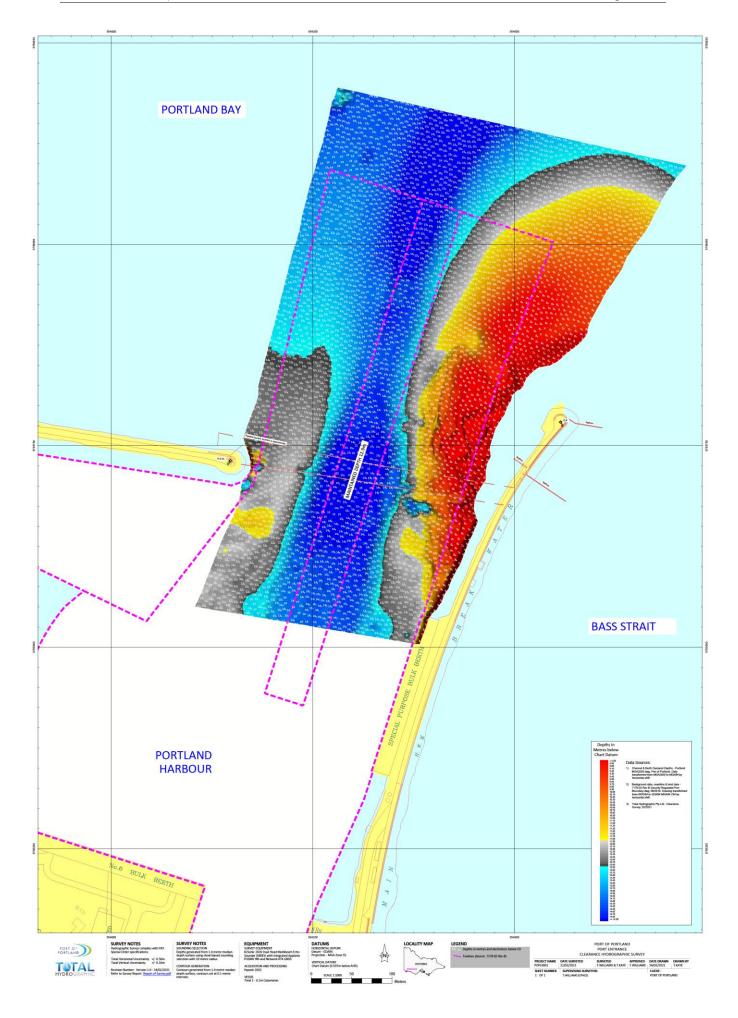
Mariners are advised that sand has accumulated to the west of the main breakwater in the vicinity of the Beacon (Q.R) marking the entrance.

Shoaling extends approximately 90 metres to the west of the breakwater with a least depth of 7.3 metres at the channel toe line. The shoaling decreases as it extends to the west of the tow line as detailed in the drawing below.

The deep-water channel is free of shoaling.

Mariners are advised to navigate with additional caution when entering and departing the Port of Portland.
